## **PLAR**

# **CONFIDENTIAL INSPECTION REPORT**

Inspection Address
1750 Starstone Dr., Ryncho Palos Verdes, CA 90275

Tuesday, October 14, 2008

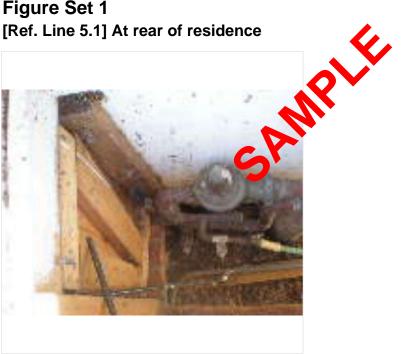
Figure 1.1 - DSCN1604

[Ref. Line 5.1] At rear of residence

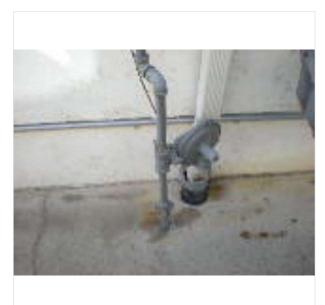
Figure 2.1 - DSCN1605

The gas main shut-off is located in the side of you should be aware that gas leaks are not uncommon, particularly underground ones, and that they can be difficult to detect without the use of sophisticated instruments, which is why natural gas is oddized in the manufacturing process.

[Ref. Line 5.5] In the house side yard

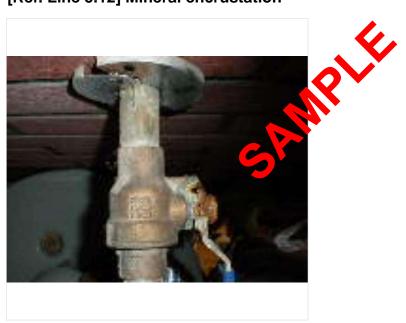
Figure 3.1 - DSCN1592

There is mineral encrustation on the cold-water shutt-off valve, probably as a consequence of leaks that have sealed themselves.

# Figure Set 3 [Ref. Line 5.12] Mineral encrustation

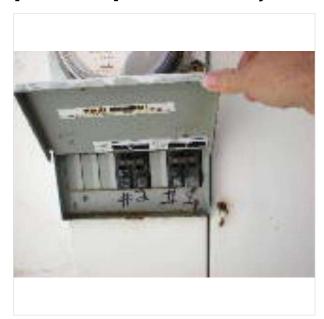
Figure 4.1 - DSCN1606

# Figure Set 4 [Ref. Line 6.4] In the house side yard

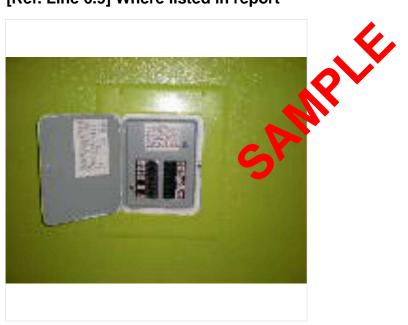
Figure 5.1 - DSCN1607

# Figure Set 5 [Ref. Line 6.9] Where listed in report

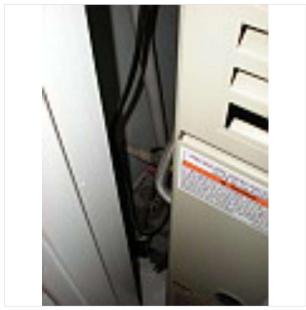
Figure 6.1 - DSCN1601

AMPLE 7.5 Gas shut-off valve is difficult to access in ase of emergency. Recommended further evaluation by a qualified contractor

# Figure Set 6 [Ref. Line 7.5] Gas valve
